Mobile Pentium® II Processor Specification Update

Release Date: August 1999

Order Number: 243887-013

The Mobile Pentium® II processor or the Intel® Pentium® II Processor Mobile Module may contain design defects or errors known as errata which may cause the product to deviate from published specifications. Current characterized errata are documented in this Specification Update.

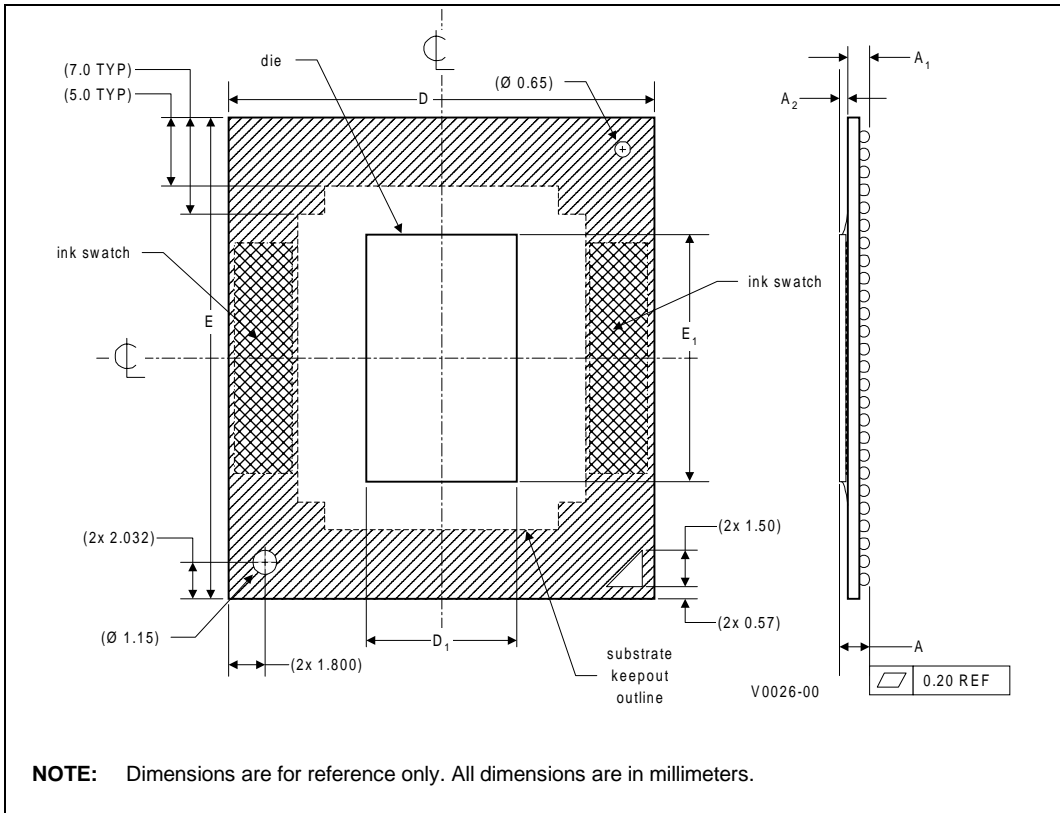
Figure 5.3. Surface-Mount BGA1 Package—Top and Side View

The following table and figures show the updated mechanical specifications for the BGA1 package, listed as Table 5.2, Figure 5.3 and Figure 5.4, respectively, in the *Mobile Pentium® II Processor in BGA Package at 366 MHz, 333 MHz, 300PE MHz, and 266PE MHz* datasheet.

1. The number shown here is different from that in last month's specification update. The maximum reference number is used.
